## Service Procedure SP-CNS-190702

### Clearing CNS175 Lower Limit Stop

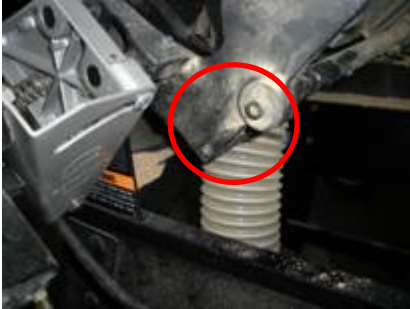
1. Tilt the blade to about 20° or more to ease access to the area you want to work on.
2. Working from the rear of the Contractor Saw, you'll find the limit stop and its sawdust at the rear corner of the saw assembly (see red circled area in the first picture.)

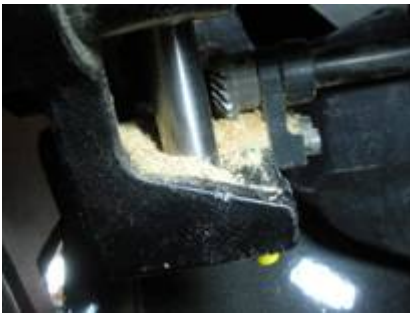
3. With heavy use, this area can accumulate a lot of sawdust (only a little of it here in the second picture.) you can clear it by use of a wire probe (a piece of coat hanger wire works well) and/or compressed air. Note that the miter gears located here will tend to pick up sawdust, and then can give trouble either raising or lowering the blade. When you feel the elevation mechanism begin to bind, **do not attempt to force them** - clear the sawdust and operations can return to normal. Applying a non-drying grease prolongs the life of these gears.

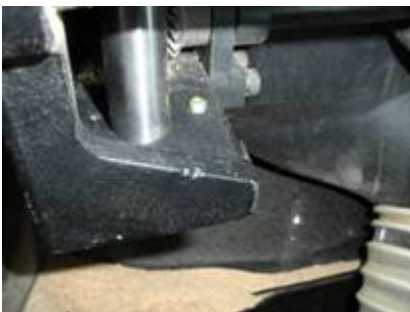
4. Once this area is cleared, as in the picture below, you should be able to get a complete raising and lowering of the saw blade.
